The value of piston rod vibration measurement in reciprocating compressors

by **Larry Leonard**
Senior Reliability Engineer
UNOCAL 76 Products Company
San Francisco Refinery

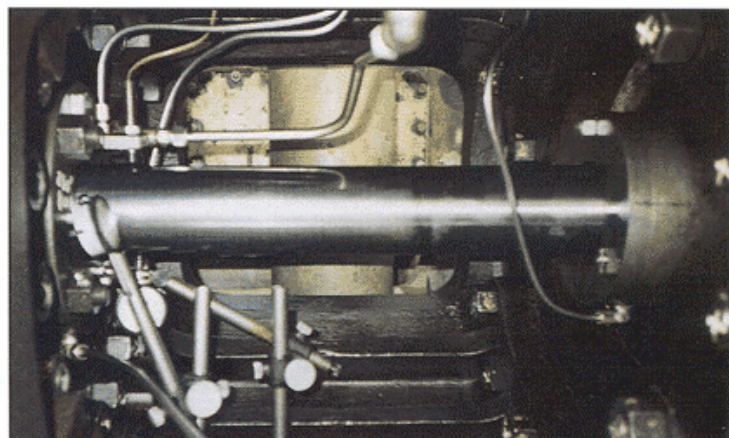
Figure 2

Rod Drop proximity probe installation.

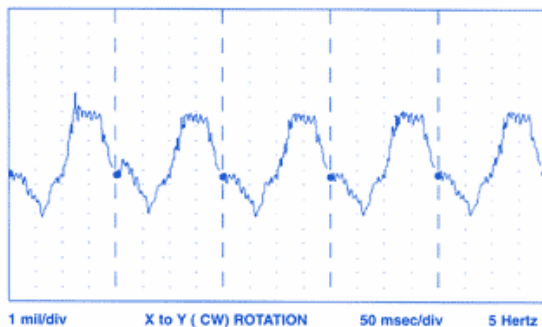
Figure 3

August 31: Rod Drop proximity probe unfiltered waveform, with normal shape.

Data was gathered on the machines every two to four weeks to assess machine condition. The rod drop vibration waveform from August 31 (Figure 3) was typical. It was sinusoidal with a frequency of 300 cpm, the running speed of the machine.

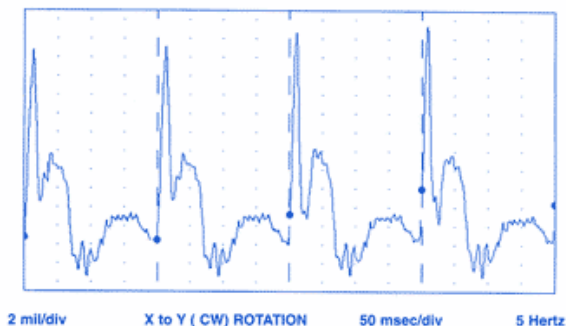
Figure 4

October 4: Rod Drop proximity probe unfiltered waveform. Spikes in the waveform had become more pronounced.

In early October, a disturbing trend developed on the 1st Stage number 2 cylinder of unit G203B. Comparison of the unfiltered waveform plots from August 31 (Figure 3) and October 4 (Figure 4) indicated that both vibration amplitude and waveform shape had changed significantly. The amplitude started at 229 μm (9 mils) pp and, by October 4, had increased to 630 μm (24.8 mils) pp. The October 4 waveform contained sharp spikes.

There was some concern that the proximity probe might be coming loose, so the access cover on the distance piece was removed and the bracket checked. The probe installation was satisfactory, however, we observed excessive piston rod motion.

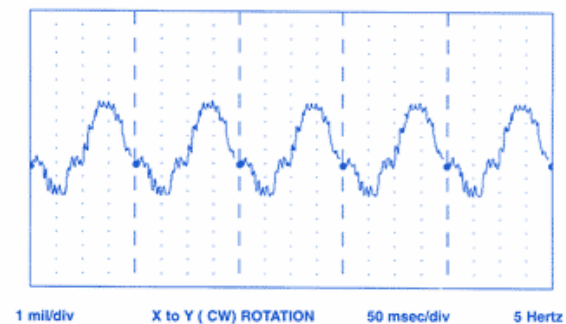
Figure 5

October 9: Rod Drop proximity probe unfiltered waveform. The waveform's shape had returned to normal.

Data acquired on October 9 (Figure 5), after the machine was put back in service, shows a vibration amplitude and form that is similar to the data acquired on 31 August (Figure 3). There was no indication of a spike on the waveform, and the vibration amplitude was 148 μm (5.8 mil) pp.

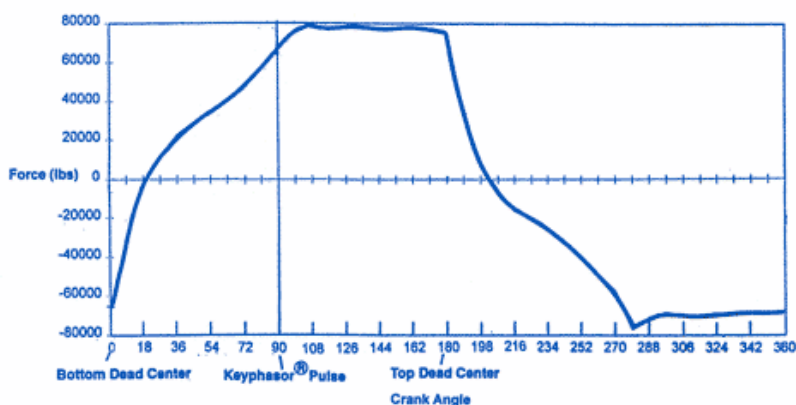
Figure 6

Waveform data was analyzed in comparison to the piston motion and Pressure Volume (PV) curves. We used the PV diagrams to calculate rod load (Figure 6) and found that the spike in the waveform occurred at the point of

maximum compressive rod load. This raised the possibility of excessive rod flexure caused by a crack. The increase in piston rod vibration was of sufficient concern that a shutdown and inspection was planned. At the very least, the high rod vibration would cause excessive packing wear.

Combined Rod Load in relation to the crank angle.

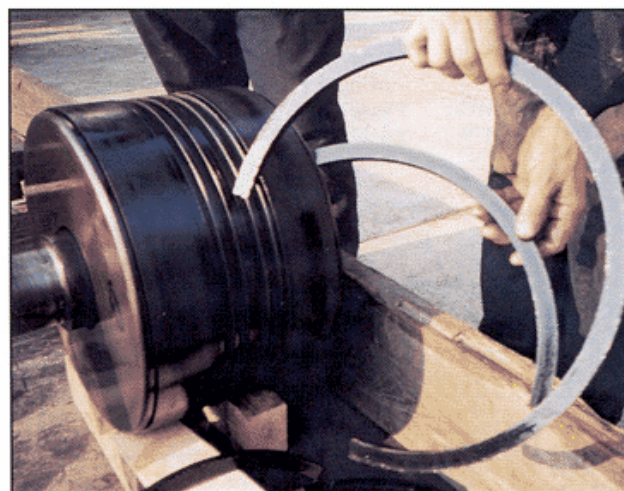
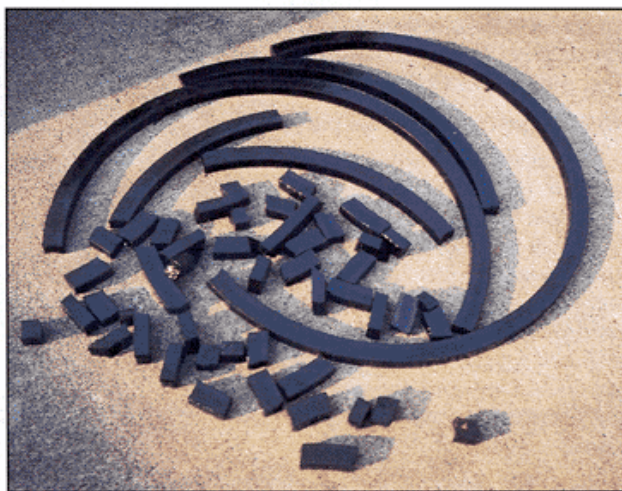
Figure 7

The primary problem noted was that all four of the piston rings were broken in numerous pieces (Figure 7). In addition, piston rod runout was 152 μm (6.0 mils), due in part to a 63.5 μm (2.5 mil) bow in the rod. The wrist pin bushing clearance was 241 to 254 μm (9.5 to 10 mils), which was slightly out of tolerance — 9 mils was the maximum allowable clearance. Finally, a crankshaft counterweight was improperly seated on the crankshaft. These items were corrected, new piston rings installed, and the unit was put back in service.

Monitoring and trending piston rod vibration proved to be a valuable tool for assessing machine condition. Increased vibration levels were probably due to the breakup of the piston rings and the resulting uneven pressurization in the ring groove. The other problems detected probably would not have caused the observed piston rod vibration. This compressor has had similar piston ring failures in the past. An investigation is under way to determine the root cause of the failure and to design an appropriate ring

The broken rings that were removed from the 1st stage number 2 cylinder of unit G203B.
